Sweater Evaluation Images: Issues and Solutions

GLOBAL TECHNICAL DESIGN

Sweater Evaluation Images

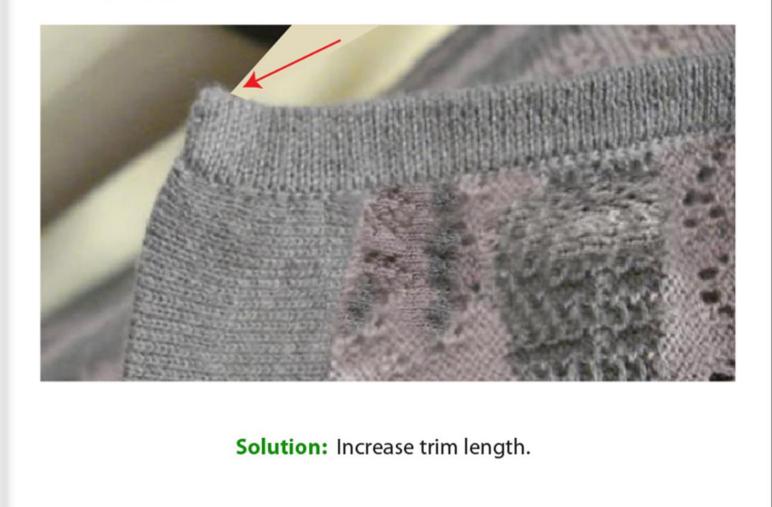
Problem: Trim length is too short and is pulling and curling up.

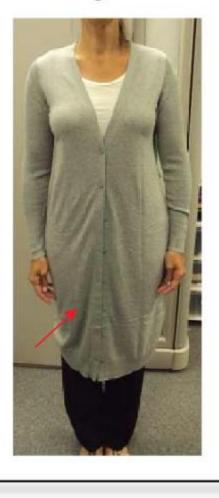
Incorrect: Placket is too short and is pulling up at CF, causing drag lines.

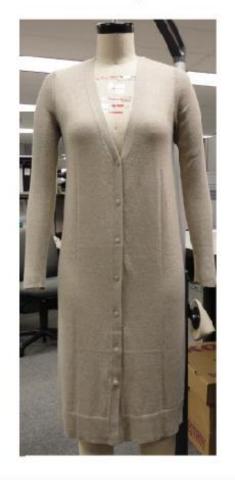
Correct: Placket hangs evenly at hem and there are no drag lines.

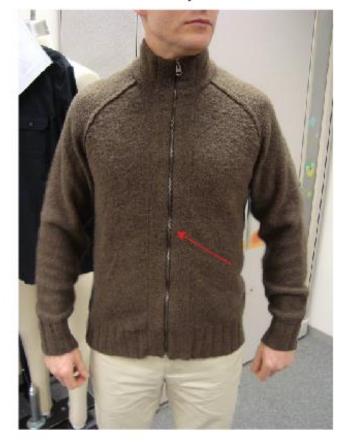
Incorrect:

Zipper length is too long, and zipper is not laying nicely on the body.

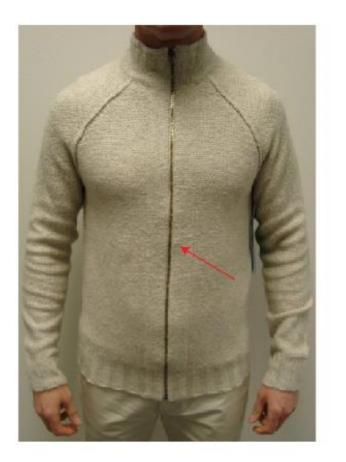
Correct:

Zipper length is correct and zipper is laying flat to the body.

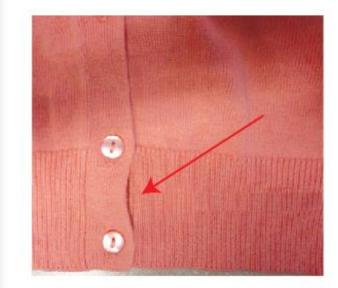
Correct: Placket is not stretched out and lays nicely closed when worn, press garment unbuttoned if needed.

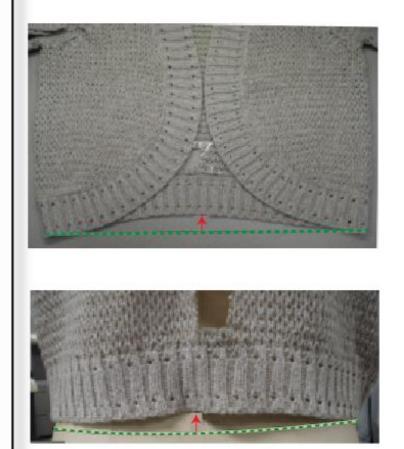
Problem:

Garment is curving up at back hem both flat and on the body.

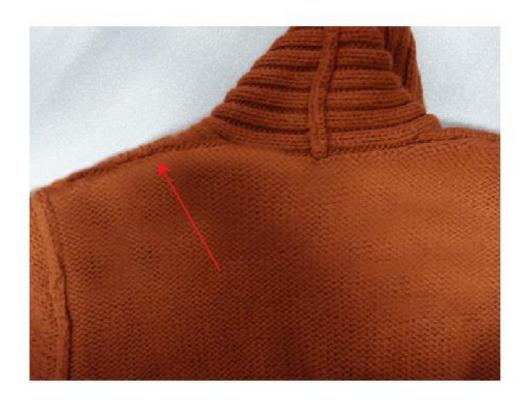
Problem: Shoulder seams are placed too far back, causing the garment balance to be effected.
